**Flood Control Project Maintenance
Levee Inspections**
LMA District Cover Sheet
Spring 2018 Levee Inspection Results

Sacramento River West Side Levee District

Spring 2018 Levee Inspection Results

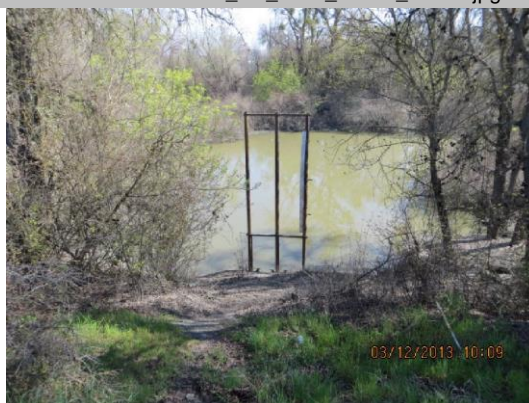
Photo 2 of 3 : UCIP_SP_2018_10087_17234.jpg

Comment Code						
Inspector Comment						
FS_ID:10087						
DS_ID:20224						
EP_NO: N/A						
Repair Type: Non-Urgent						
Crossing Status: Found						
UCIP Comments: Headwall on WS undermined about 3-4-feet.						
FIELD_STRUCT_DESC: 1 of 3: 36-inch steel drainage pipe through the						
levee, 30.0 feet below the crown. Flap gate on the waterside (WS) end.						
24-inch pipe sleeved through the 36-inch pipe. Annular space between						
pipes grouted. Pumps in pump house with walkway on landside (LS)						
toe. [Additional Reference(s): DWR Levee Log, 2006. USACE						
Sacramento O&M Manual 130, May 1960 (HLM 0.15)].						
FS Date: 3/12/2013

Air vents at outlet on WS toe.

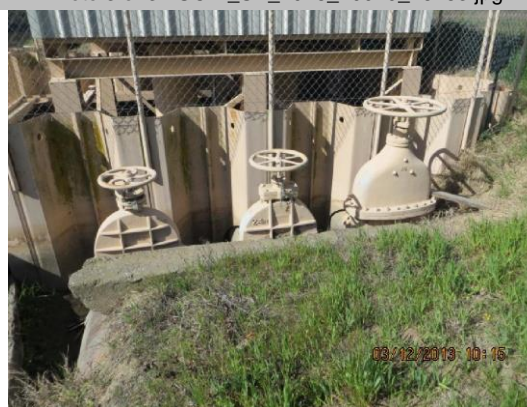
Photo 3 of 3 : UCIP_SP_2018_10910_18183.jpg

LM Start	0.14	Rating **	M	Issue No.	1553 (cont)	
LM End	0.14	Issue Type +	Ma	Location *		
Category	Supplemental			GPS Latitude/Longitude		
				Start	End	
Item	DWR UCIP LMA Responsibility			38.801491 °	38.801491 °	
				-121.725184 °	-121.725184 °	
DWR ID						
Comment Code						
Inspector Comment						
FS_ID:10910 DS_ID:20357 EP_NO: N/A Repair Type: Non-Urgent Crossing Status: Found UCIP Comments: Headwall undermined 3-4-feet on WS toe. FIELD_STRUCT_DESC: 3 of 3: 36-inch steel drainage pipe through the levee, 30 feet below the crown. Flap gate on the waterside (WS) end. 24-inch pipe sleeved through the 36-inch pipe. Annular space between pipes grouted. Pumps inside pump house with a walkway on the landside (LS) toe. [Additional Reference(s): DWR Levee Log, 2006. USACE Sacramento O&M Manual 130, May 1960 (HLM 0.15)]. FS Date: 3/12/2013

Slide gates at pumphouse on LS toe.

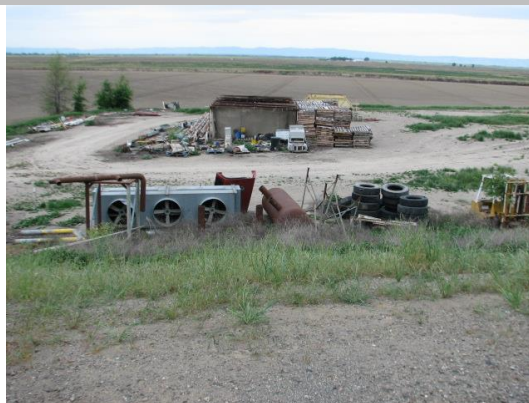
Photo 1 of 2 : SP_2018_NA0016_435_1550_20180306_00082.jpg

LM Start	2.40	Rating **	M	Issue No.	1550
LM End	2.40	Issue Type +	En	Location *	LS
Category	Earthen Levee			GPS Latitude/Longitude	
				Start	End
Item	Encroachments			38.832295 °	38.832295 °
				-121.729408 °	-121.729408 °
DWR ID	DWR_NA0016_01_f_2013_1550				
Comment Code					
EQ : Equipment					
Inspector Comment					
Equipment are at the levee toe.

Pieces of machinery and debris at the levee toe. Spring 2014

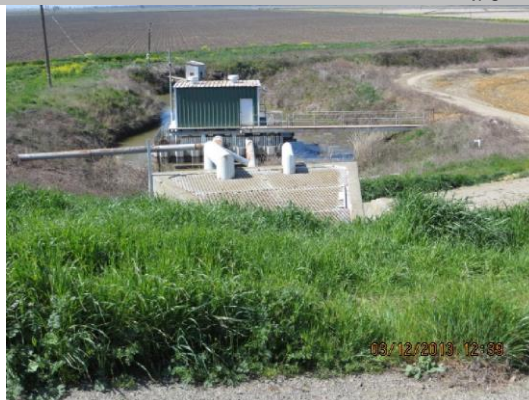
Photo 2 of 3 : UCIP_SP_2018_10125_17282.jpg

LM Start	3.54	Rating **	A/W	Issue No.	1556 (cont)	
LM End	3.54	Issue Type +	Ma	Location *		
Category	Supplemental			GPS Latitude/Longitude		
				Start		End
Item	DWR UCIP LMA Responsibility			38.846492 °		38.846492 °
				-121.730066 °		-121.730066 °
DWR ID						
Comment Code						
Inspector Comment						
FS_ID:10125 DS_ID:20331 EP_NO: N/A Repair Type: No Action Needed Crossing Status: Found UCIP Comments: FIELD_STRUCT_DESC: 5-foot by 5-foot reinforced concrete box drainage tunnel through the levee, 33 feet below the crown. Slide gate at outlet on the waterside (WS) toe. Tunnel runs from concrete U-shaped riser unit on the landside (LS) shoulder to the WS toe. Steel walkway to slide gate actuator on the WS berm. [Additional Reference(s): USACE Sacramento O&M Manual 130, May 1960 (HLM 3.59)]. FS Date: 3/12/2013

Pumphouse at LS toe and concrete riser on LS shoulder.

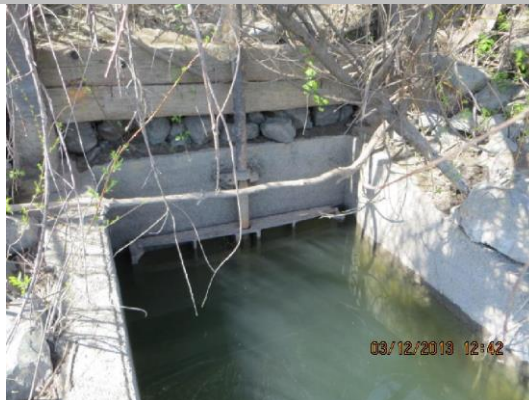
Photo 3 of 3 : UCIP_SP_2018_10125_17281.jpg

Slide gate at outlet at river side.

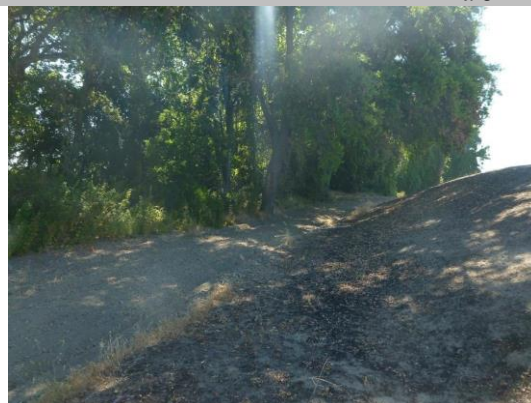
Photo 1 of 3 : LEVAL_SP_2018_183_1658.jpg

LM Start	3.94	Rating **	A/W	Issue No.	119	
LM End	4.06	Issue Type +	Ob	Location *		
Category	Supplemental			GPS Latitude/Longitude		
				Start	End	
Item	2017 Storm Damage			38.850817 °	38.851869 °	
				-121.725431 °	-121.725569 °	
DWR ID	DWR_NA0016_01_f_2017_119					
Comment Code						
Inspector Comment						
Levee Evaluation Comments						
Description:						
Site ID No:183						
Site Designation:SRWLD-01						
Repair Type: Seepage						
Rating:Area of Concern						
Field Date:7/17/2017						
Notes:

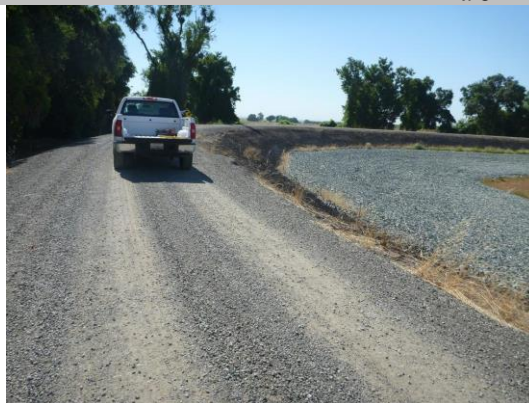
Photo 2 of 3 : LEVAL_SP_2018_183_1661.jpg

LM Start	3.94	Rating **	A/W	Issue No.	119 (cont)	
LM End	4.06	Issue Type +	Ob	Location *		
Category	Supplemental			GPS Latitude/Longitude		
				Start		End
Item	2017 Storm Damage			38.850817 °	38.851869 °	
				-121.725431 °	-121.725569 °	
DWR ID	DWR_NA0016_01_f_2017_119					
Comment Code						
Inspector Comment						
Levee Evaluation Comments						
Description:						
Site ID No:183						
Site Designation:SRWLD-01						
Repair Type: Seepage						
Rating:Area of Concern						
Field Date:7/17/2017						
Notes:

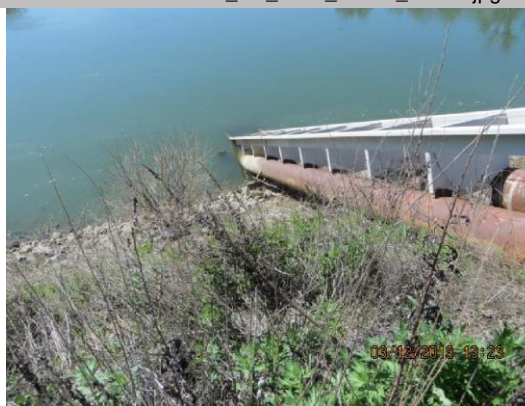
Photo 3 of 3 : UCIP_SP_2018_10129_17289.jpg

Comment Code					
Inspector Comment					
FS_ID:10129 DS_ID:20228 EP_NO: 1297 Repair Type: Non-Urgent Crossing Status: Found UCIP Comments: Leak at flowmeter on WS berm may become problem in near future. FIELD_STRUCT_DESC: *REMOVED* 2 of 2: 16-inch steel irrigation pipe through the levee, 5.2 feet below the crown. Slant pumps in a metal pump house on the waterside (WS) bank, supported on a steel structure. Pipes discharge into a 9.5-foot by 12-foot concrete distribution box on the landside (LS). Sparline flow meter on pipes near the WS toe. (Permit No. 1297, 1948 - River Farms Company of California; removed under Permit No. 8501, 2012 - River Garden Farms, Inc.). [Additional Reference(s): DWR Levee Log, 2006. USACE Sacramento O&M Manual 130, May 1960 (HLM 6.89) listed as a 14-inch pipe]. FS Date: 3/12/2013

Pipe and fish screen ramp on WS.

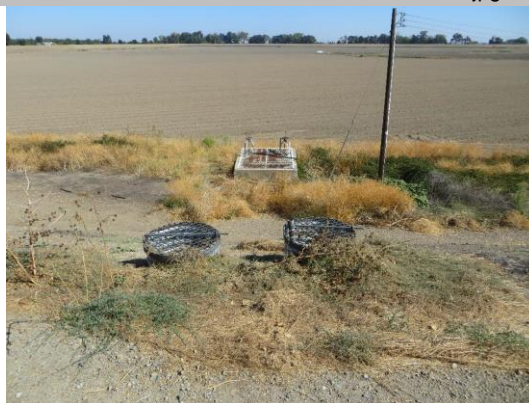
Photo 2 of 3 : UCIP_SP_2018_46765_74701.jpg

Comment Code						
Inspector Comment						
FS_ID:46765 DS_ID:25125 EP_NO: 8501 Repair Type: Non-Urgent Crossing Status: Found UCIP Comments: field inspection of the site revealed a few minor actions: 1. there are metal fence posts located near the pipe that should be cleared out for safety, 2. vegetation around the pipes should be cleared as it limits inspection, 3. some burrowing activity was noticed nearby the pipes. FIELD_STRUCT_DESC: 1 of 2: 20-inch steel irrigation pipe, at an unknown depth, and 16-inch steel irrigation pipe, at an unknown depth, are located at levee mile 6.889 and 6.89, respectively. Both pipes have a protective paint coating. The pipes are used to supply irrigation water to the adjacent fields. On the waterside (WS) of the levee, the pipes are above ground and follow the slope of the bank into the river. A metal pump house, supported on a steel frame, is located on a bench on the WS of the levee. When the pumps are operational, a drum fish screen is lowered over the pipe intakes on a track. Both irrigation pipes travel through the levee and have siphon breakers inside corrugated metal riser units on the landside (LS) crest of the levee. The pipes discharge under submerged conditions to a 9.5-foot by 12-foot concrete distribution box. There are two gated outlets on the distribution box that lead to distribution canals. FS Date: 10/9/2015 9:00:32 AM

view from levee crest along pipe profile toward land side of levee. CMP risers with siphon breakers and distribution box near land side levee toe.

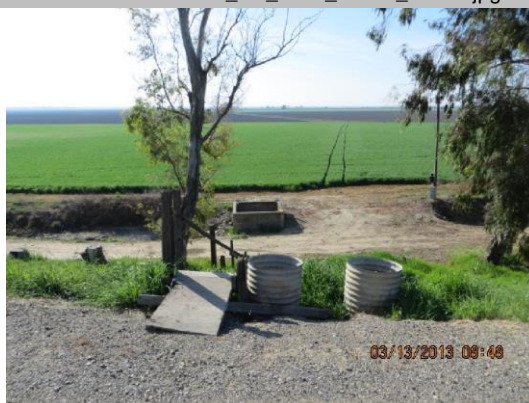
Photo 1 of 3 : UCIP_SP_2018_10144_17307.jpg

Comment Code					
Inspector Comment					
FS_ID:10144 DS_ID:20428 EP_NO: 18206 Repair Type: Non-Urgent Crossing Status: Found UCIP Comments: Flap gates rusted through at concrete distribution box on LS toe. FIELD_STRUCT_DESC: 1 of 2: 20-inch steel irrigation pipe through the levee, 4.7 feet below the crown. Slant pump inside pump house on the waterside (WS) berm. Siphon breaker inside corrugated metal riser unit on the shoulder. Flap gate on pipe inside concrete distribution box on the landside (LS). Wooden steps on both slopes. (Permit No. 18206, 2007 - River Garden Farms). (Replaced 20-inch pipe installed under Permit No. 9377, 1974 - Faye Properties, Inc.). [Additional Reference(s): DWR Levee Log, 2006]. FS Date: 3/13/2013

Stairs, distribution box, and air vent in CMP riser on LS.

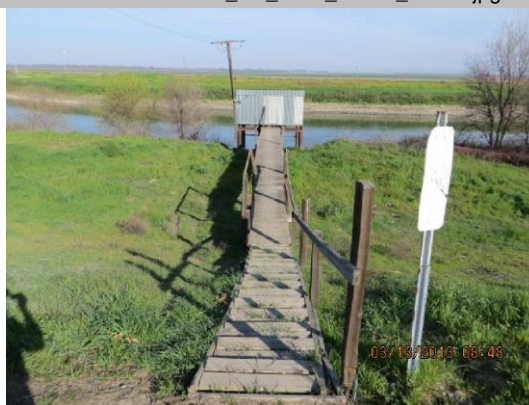
Photo 2 of 3 : UCIP_SP_2018_10144_17306.jpg

Stairs and pump on WS.

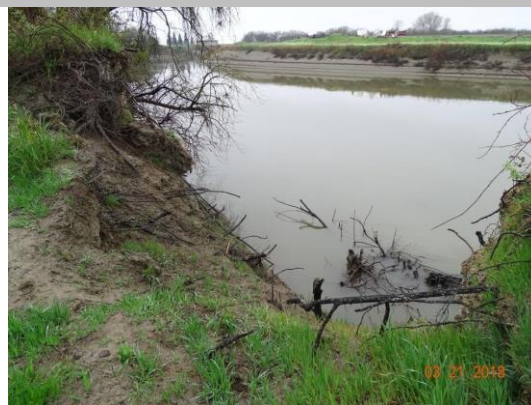
Photo 2 of 3 : SP_2018_NA0016_435_112_20180326_00251.jpg

LM Start	8.55	Rating **	A/W	Issue No.	112
LM End	8.55	Issue Type +	Ma	Location *	WS
Category	Earthen Levee			GPS Latitude/Longitude	
				Start	End
Item	Erosion / Bank Caving			38.857422 °	38.857422 °
				-121.780870 °	-121.780870 °
DWR ID	DWR_NA0016_01_s_2018_112				
Comment Code					
E1 : Note and monitor erosion site.					
Inspector Comment					
Location on waterside berm where oak tree fell and removed soil around the roots. There is a bend in the river at this location and has to potential to erode. Recommend monitoring.

View of the remaining roots, facing upstream. Spring 2018.

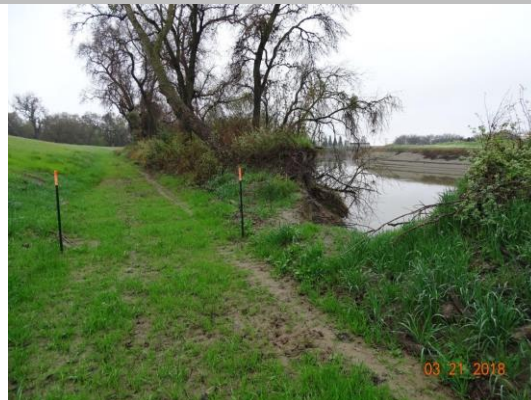
Photo 3 of 3 : SP_2018_NA0016_435_112_20180326_00252.jpg

Additional view of the berm. Spring 2018.

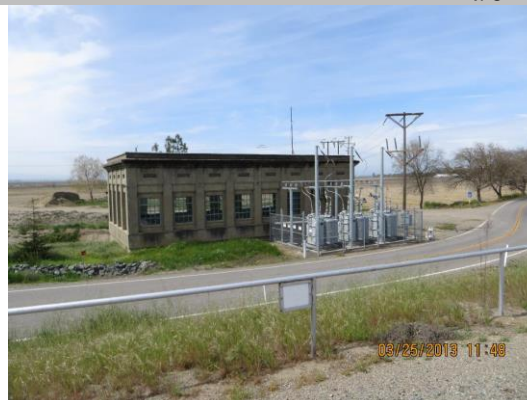
Photo 1 of 3 : UCIP_SP_2018_10146_17312.jpg

Comment Code						
Inspector Comment						
FS_ID:10146 DS_ID:20230 EP_NO: 9376 Repair Type: No Action Needed Crossing Status: Found UCIP Comments: FIELD_STRUCT_DESC: [El Dorado Bend Pumping Plant] 1 of 4: 50-inch sleeved through existing 54-inch concrete encased steel drainage pipe through the levee, 26.5 feet below the crown. Gate valves on the waterside (WS) ends of the pipes. Walkway provided to the control valves and around the pump house on the landside (LS). Pipes originate in a large concrete pool at the pump house on the LS. (54-inch pipe [HLM 5.27] authorized under Automatic Board Order (ABO) issued as Permit No. 9376, 1974 - Reclamation District Nos. 2047 and 108; 50-inch pipe sleeved through existing 54-inch pipe and trash rack repairs authorized under maintenance in 2013). [Additional Reference(s): DWR Levee Log, 2006. USACE Sacramento O&M Manual 130, May 1960 (HLM 8.99)]. FS Date: 3/13/2013

Pumphouse on LS toe.

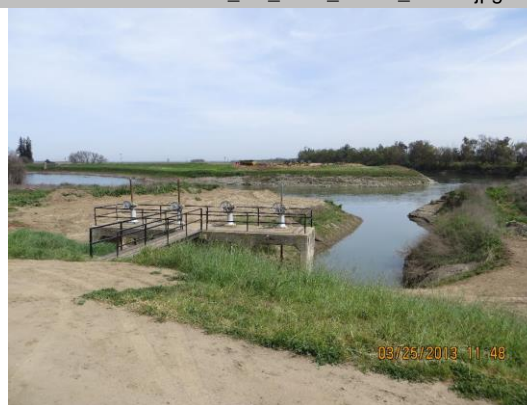
Photo 2 of 3 : UCIP_SP_2018_10146_17311.jpg

Walkway to slide gate actuators on WS shoulder.

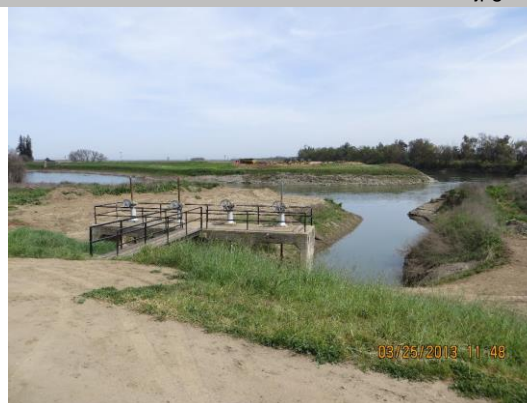
Photo 2 of 3 : UCIP_SP_2018_10147_17315.jpg

Comment Code						
Inspector Comment						
FS_ID:10147						
DS_ID:20361						
EP_NO: 9376						
Repair Type: No Action Needed						
Crossing Status: Found						
UCIP Comments:						
FIELD_STRUCT_DESC: [EI Dorado Bend Pumping Plant] 2 of 4: 54-inch concrete encased steel drainage discharge pipe through the levee, 26.5 feet below the crown. Gate valves on both ends of the pipe. Walkway provided to the gate valves on the waterside (WS) shoulder. Pipe not visible on landside (LS) toe. (54-inch pipe [HLM 5.27] authorized under Automatic Board Order (ABO) issued as Permit No. 9376, 1974 - Reclamation District Nos. 2047 and 108; now work was done in 2013 at this location). [Additional Reference(s): DWR Levee Log, 2006. USACE Sacramento O&M Manual 130, May 1960 (HLM 8.99)].						
FS Date: 3/13/2013

Walkway to slide gate actuators on WS shoulder.

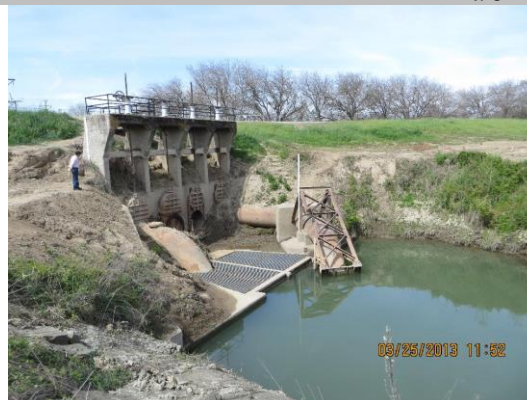
Photo 3 of 3 : UCIP_SP_2018_10147_17314.jpg

Item	DWR UCIP LMA Responsibility			38.856554 °	38.856554 °	
				-121.785613 °	-121.785613 °	
DWR ID						
Comment Code						
Inspector Comment						
FS_ID:10147						
DS_ID:20361						
EP_NO: 9376						
Repair Type: No Action Needed						
Crossing Status: Found						
UCIP Comments:						
FIELD_STRUCT_DESC: [EI Dorado Bend Pumping Plant] 2 of 4: 54-inch concrete encased steel drainage discharge pipe through the levee, 26.5 feet below the crown. Gate valves on both ends of the pipe. Walkway provided to the gate valves on the waterside (WS) shoulder. Pipe not visible on landside (LS) toe. (54-inch pipe [HLM 5.27] authorized under Automatic Board Order (ABO) issued as Permit No. 9376, 1974 - Reclamation District Nos. 2047 and 108; now work was done in 2013 at this location). [Additional Reference(s): DWR Levee Log, 2006. USACE Sacramento O&M Manual 130, May 1960 (HLM 8.99)].						
FS Date: 3/13/2013

Slide gates and pipes at outlet structure on WS toe.

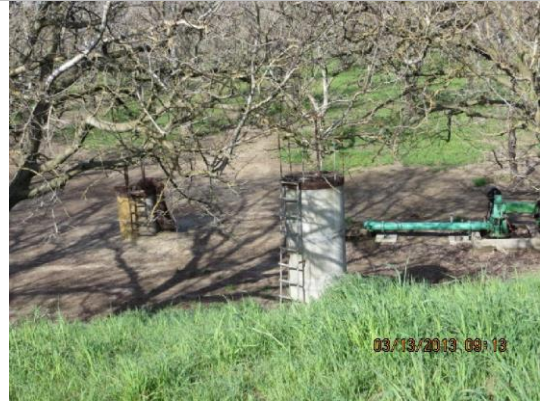
Photo 1 of 3 : UCIP_SP_2018_50039_17328.jpg

FS_ID:50039
DS_ID:20231
EP_NO: 1641
Repair Type: Non-Urgent
Crossing Status: Found
UCIP Comments: 09/23/2016 - pipe is not actively used. No power to pump platform. vegetation growth obscuring view along pipe alignment on the WS toe (T.Hatch/UCIP) 09/01/2016 pipe is visible on the WS slope of the levee. The pipe appears intact on the WS and does not appear to have a meter. The siphon breaker on the LS slope appears to have been removed and replaced by a cap. No holes or missing connections were visible. WS levee slope appears to have a slight depression in the vicinity of the exposed pipe. (T. Hatch/UCIP)

Concrete riser on LS toe.

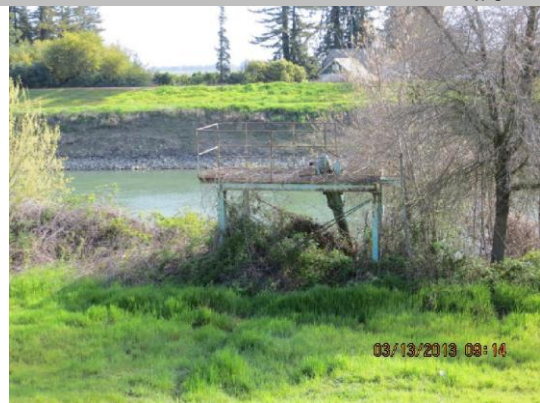
Photo 2 of 3 : UCIP_SP_2018_50039_17327.jpg

Pump platform on WS.

Comment Code						
Inspector Comment						
FS_ID:50039 DS_ID:20231 EP_NO: 1641 Repair Type: Non-Urgent Crossing Status: Found UCIP Comments: 09/23/2016 - pipe is not actively used. No power to pump platform. vegetation growth obscuring view along pipe alignment on the WS toe (T.Hatch/UCIP) 09/01/2016 pipe is visible on the WS slope of the levee. The pipe appears intact on the WS and does not appear to have a meter. The siphon breaker on the LS slope appears to have been removed and replaced by a cap. No holes or missing connections were visible. WS levee slope appears to have a slight depression in the vicinity of the exposed pipe. (T. Hatch/UCIP) 03/13/2013 - Meter removed from the pipe on the WS and pipe is open. Pipe appears abandoned, and, if so, should be abandoned properly. (W. Wylie/UCIP) FIELD_STRUCT_DESC: *ABANDONED* 14-inch steel irrigation pipe through the levee, 5.2 feet below the crown. Slant pump on a concrete pump platform on the waterside (WS). Siphon breaker on the landside (LS) slope. Sparling flow meter on the pipe on the WS slope. 42-inch concrete standpipe in a concrete distribution box at the landside (LS) toe. (Permit No. 1641, 1952 - William Erdman Jr.). [Additional Reference(s): DWR Levee Log, 2006. USACE Sacramento O&M Manual 130, May 1960 (HLM 9.31)]. FS Date: 9/23/2016

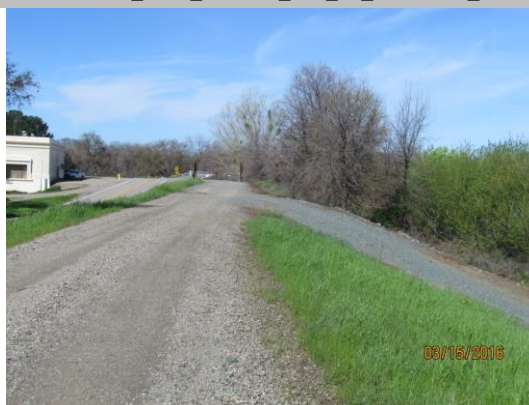
Photo 1 of 2 : SP_2018_NA0016_435_29_20180306_00019.jpg

LM Start	9.68	Rating **	A/W	Issue No.	29
LM End	9.79	Issue Type +	Ma	Location *	WS
Category	Earthen Levee			GPS Latitude/Longitude	
				Start	End
Item	Vegetation			38.862345 °	38.862848 °
				-121.791337 °	-121.793267 °
DWR ID	DWR_NA0016_01_s_2012_29				
Comment Code					
V8 : Environmental Requirements.					
Inspector Comment

View of the revegetation site on the waterward side of the levee looking upstream. Spring 2016.

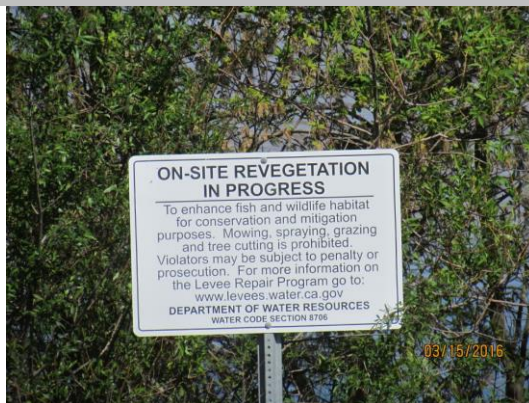
Photo 2 of 2 : SP_2018_NA0016_435_29_20180306_00020.jpg

Revegetation site sign. Spring 2016.

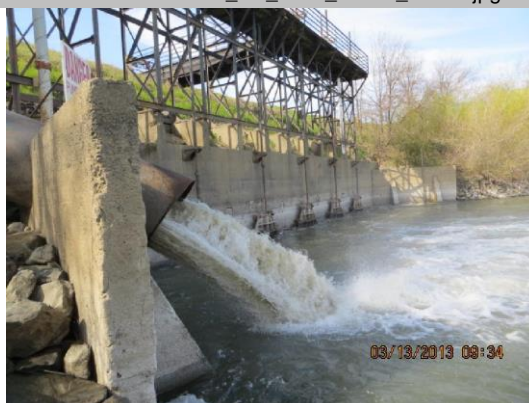
Photo 1 of 3 : UCIP_SP_2018_10163_17342.jpg

LM Start	9.75	Rating **	A/W	Issue No.	1567
LM End	9.75	Issue Type +	Ma	Location *	
Category	Supplemental			GPS Latitude/Longitude	
				Start	End
Item	DWR UCIP LMA Responsibility			38.862619 °	38.862619 °
				-121.792510 °	-121.792510 °
DWR ID					
Comment Code					
Inspector Comment					
FS_ID:10163 DS_ID:20415 EP_NO: 680 Repair Type: No Action Needed Crossing Status: Found UCIP Comments: FIELD_STRUCT_DESC: 42-inch concrete encased steel drainage pipe through the levee, 17.5 feet below the crown. Screw gate on the waterside (WS) end. Pump on platform in canal on landside (LS) toe. 12-inch standpipe along pipe alignment on LS toe. Staff gauge to 47 feet on structure. (Permit No. 680, 1936 - Reclamation District No. 108). [Additional Reference(s): USACE Sacramento O&M Manual 130, May 1960 (HLM 9.87)]. FS Date: 3/13/2013

Pipe at outlet on WS toe.

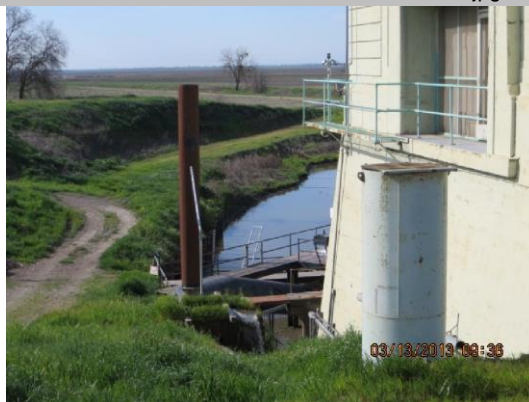
Photo 2 of 3 : UCIP_SP_2018_10163_17341.jpg

12-inch steel standpipe at LS toe with 36-inch steel riser.

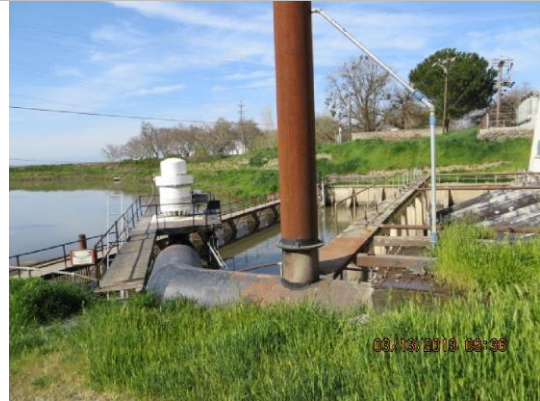
Photo 3 of 3 : UCIP_SP_2018_10163_17340.jpg

LM Start	9.75	Rating **	A/W	Issue No.	1567 (cont)	
LM End	9.75	Issue Type +	Ma	Location *		
Category	Supplemental			GPS Latitude/Longitude		
				Start	End	
Item	DWR UCIP LMA Responsibility			38.862619 °	38.862619 °	
				-121.792510 °	-121.792510 °	
DWR ID						
Comment Code						
Inspector Comment						
FS_ID:10163 DS_ID:20415 EP_NO: 680 Repair Type: No Action Needed Crossing Status: Found UCIP Comments: FIELD_STRUCT_DESC: 42-inch concrete encased steel drainage pipe through the levee, 17.5 feet below the crown. Screw gate on the waterside (WS) end. Pump on platform in canal on landside (LS) toe. 12-inch standpipe along pipe alignment on LS toe. Staff gauge to 47 feet on structure. (Permit No. 680, 1936 - Reclamation District No. 108). [Additional Reference(s): USACE Sacramento O&M Manual 130, May 1960 (HLM 9.87)]. FS Date: 3/13/2013

Pump on platform at LS toe.

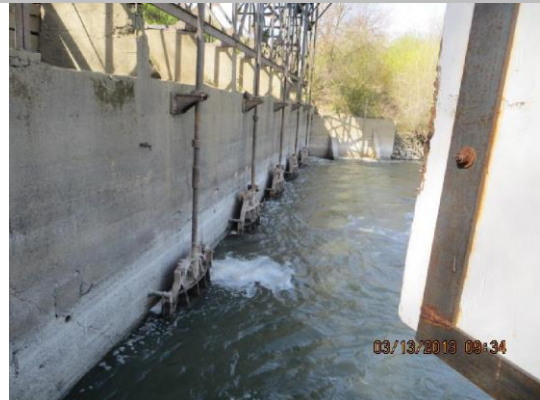
Photo 1 of 3 : UCIP_SP_2018_10164_17345.jpg

LM Start	9.75	Rating **	A/W	Issue No.	1568
LM End	9.75	Issue Type +	Ma	Location *	
Category	Supplemental			GPS Latitude/Longitude	
				Start	End
Item	DWR UCIP LMA Responsibility			38.862615 °	38.862615 °
				-121.792582 °	-121.792582 °
DWR ID					
Comment Code					
Inspector Comment					
FS_ID:10164					
DS_ID:20232					
EP_NO: N/A					
Repair Type: No Action Needed					
Crossing Status: Found					
UCIP Comments:					
FIELD_STRUCT_DESC: 1 of 5: 60-inch reinforced concrete drainage culvert through the levee, 35 feet below the crown. Screw gates on walkway at waterside (WS) shoulder. Staff gauge to 47.0 feet on structure. [Additional Reference(s): DWR Levee Log, 2006. USACE Sacramento O&M Manual 130, May 1960 (HLM 9.87)].					
FS Date: 3/13/2013

Slide gates at concrete headwall at river

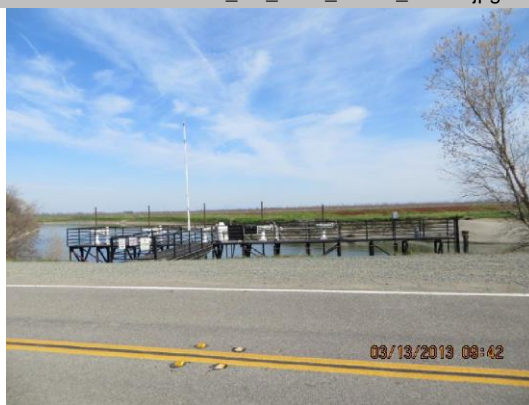
Photo 3 of 3 : UCIP_SP_2018_10164_17343.jpg

Slide gate actuators on WS shoulder.

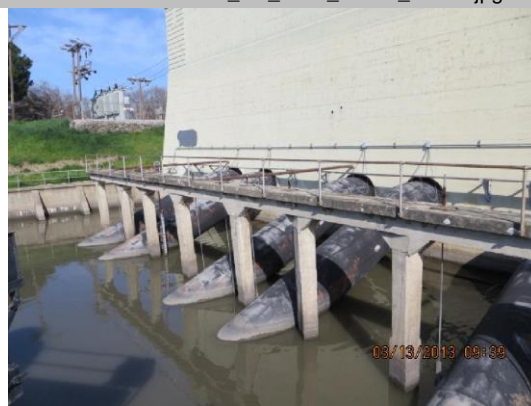
Photo 2 of 3 : UCIP_SP_2018_10168_17359.jpg

LM Start	9.76	Rating **	A/W	Issue No.	1570 (cont)	
LM End	9.76	Issue Type +	Ma	Location *		
Category	Supplemental			GPS Latitude/Longitude		
				Start		End
Item	DWR UCIP LMA Responsibility			38.862633 °		38.862633 °
				-121.792669 °		-121.792669 °
DWR ID						
Comment Code						
Inspector Comment						
FS_ID:10168 DS_ID:20365 EP_NO: N/A Repair Type: No Action Needed Crossing Status: Found UCIP Comments: FIELD_STRUCT_DESC: 3 of 5: 60-inch reinforced concrete drainage culvert through the levee, 35 feet below the crown. Screw gate actuators on metal platform on the waterside (WS) shoulder. Large pumping plant building on the landside (LS) shoulder. Staff gauge to 47 feet on structure. [Additional Reference(s): DWR Levee Log, 2006. USACE Sacramento O&M Manual 130, May 1960 (HLM 9.87)]. FS Date: 3/13/2013

Pipe at inlet to pumphouse on LS toe.

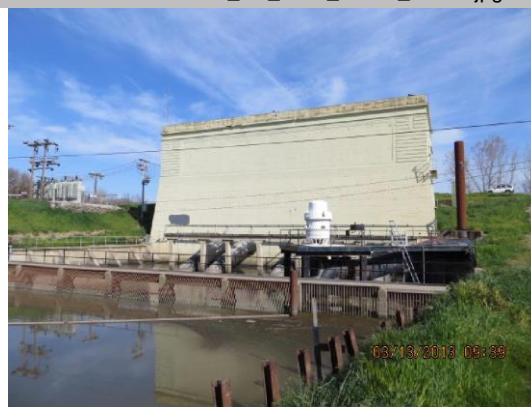
Photo 3 of 3 : UCIP_SP_2018_10168_17358.jpg

Pumphouse on LS.

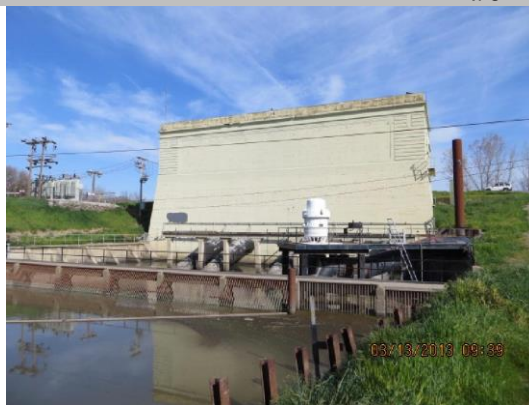
Photo 3 of 3 : UCIP_SP_2018_10169_17362.jpg

Pumphouse on LS.

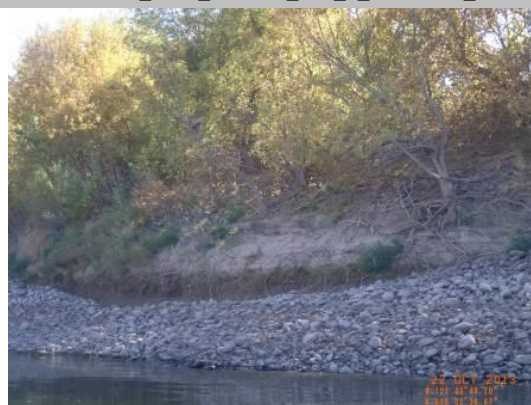
Photo 1 of 1 : SP_2018_NA0016_435_7_20180306_00006.jpg

LM Start	11.50	Rating **	M	Issue No.	7
LM End	11.53	Issue Type +	Ma	Location *	WS
Category	Supplemental			GPS Latitude/Longitude	
				Start	End
Item	2015 USACE Erosion Survey, DRAFT			38.874854 °	38.875109 °
				-121.813018 °	-121.813592 °
DWR ID	DWR_NA0016_01_s _ 2016_7				
Comment Code					
Inspector Comment					
1997 - Toe damage and loss of cobble revetment and small patch of local damage to the cobble revetment. 2000 - Cohesive vertical toe; revegetation site. 2015: No observed changes. [2015 Site ID: SAC_101-3_R]

USACE 2013 Photo #1

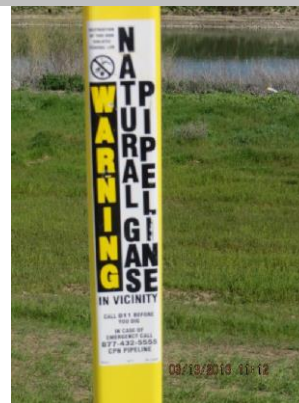
Photo 2 of 2 : UCIP_SP_2018_10203_17398.jpg

Gasline marker on WS shoulder.

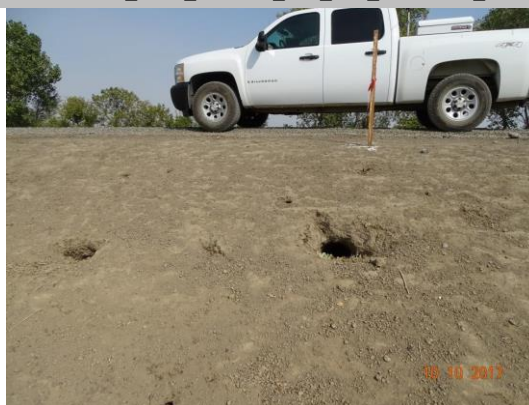
Photo 1 of 2 : SP_2018_NA0016_435_233_20180306_00079.jpg

LM Start	17.64	Rating **	M	Issue No.	233
LM End	17.64	Issue Type +	Ma	Location *	LS
Category	Earthen Levee			GPS Latitude/Longitude	
				Start	End
Item	Animal Control			38.940171 °	38.940171 °
				-121.832771 °	-121.832771 °
DWR ID	DWR_NA0016_01_s_2017_233				
Comment Code					
A3 : No rodents visible, but rodent burrows visible; need to backfill and compact or grout burrows.					
Inspector Comment					
Rodent burrows on landside levee slope.

View of additional rodent holes at the same site. Fall 2017.

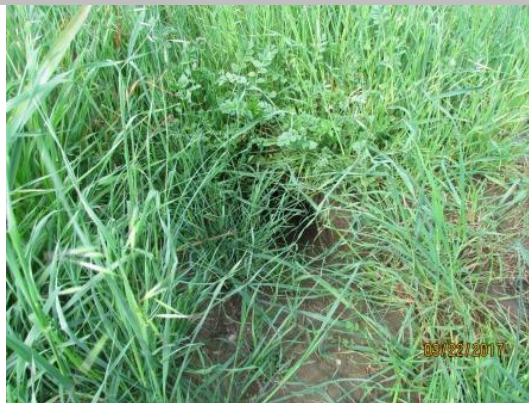
Photo 2 of 2 : SP_2018_NA0016_435_233_20180306_00080.jpg

Rodent burrow on landside levee slope. Spring 2017.

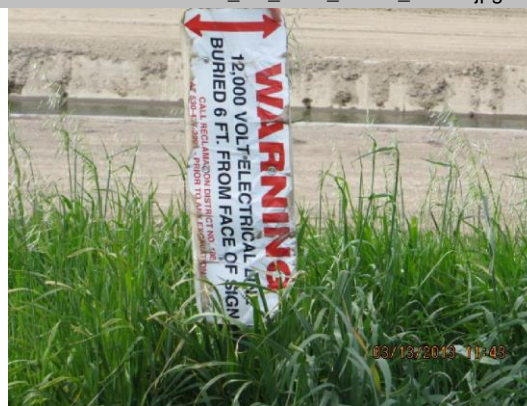
Photo 1 of 1 : UCIP_SP_2018_11323_18720.jpg

LM Start	17.94	Rating **	M	Issue No.	1574
LM End	17.94	Issue Type +	En	Location *	
Category	Supplemental			GPS Latitude/Longitude	
				Start	End
Item	DWR UCIP Field Study			38.942979 °	38.942979 °
				-121.837030 °	-121.837030 °
DWR ID					
Comment Code					
Inspector Comment					
FS_ID:11323					
DS_ID:22957					
EP_NO: 18026					
Repair Type: Non-Urgent					
Crossing Status: Found					
UCIP Comments: Conduit needs to be located and signs installed where it crosses the levee crown.					
FIELD_STRUCT_DESC: Electrical conduit of an unknown material and diameter through the levee, at an unknown depth. Signage on the landside (LS) shoulder. (Permit No. 18026, 2006 - Reclamation District No. 108).					
FS Date: 3/13/2013

Sign on LS shoulder.

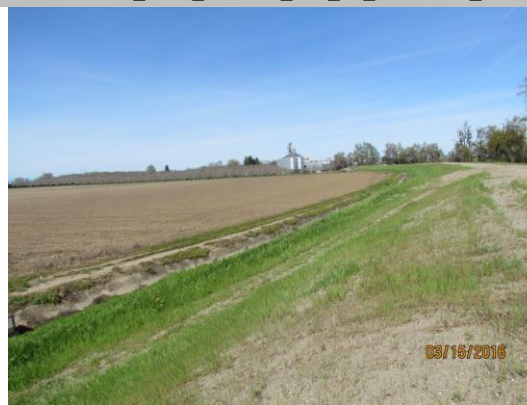
Photo 1 of 1 : SP_2018_NA0016_435_15_20180306_00013.jpg

LM Start	18.20	Rating **	M	Issue No.	15
LM End	18.46	Issue Type +	En	Location *	LS
Category	Earthen Levee			GPS Latitude/Longitude	
				Start	End
Item	Encroachments			38.946674 °	38.950263 °
				-121.837528 °	-121.837768 °
DWR ID	DWR_NA0016_01_s_2012_15				
Comment Code					
DT : Ditch					
Inspector Comment					
Concrete lined ditch runs along the toe of the levee.

View of the ditch on the landward side of the levee looking upstream. Spring 2016.

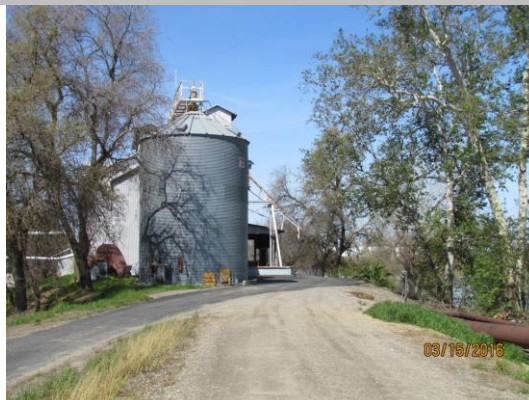
Photo 1 of 1 : SP_2018_NA0016_435_16_20180306_00014.jpg

LM Start	18.54	Rating **	M	Issue No.	16
LM End	18.54	Issue Type +	En	Location *	CR
Category	Earthen Levee			GPS Latitude/Longitude	
				Start	End
Item	Encroachments			38.951400 °	38.951400 °
				-121.838255 °	-121.838255 °
DWR ID	DWR_NA0016_01_s_2012_16				
Comment Code					
BU : Building					
Inspector Comment

View of the rice mill on the crown of the levee looking upstream. Spring 2016.

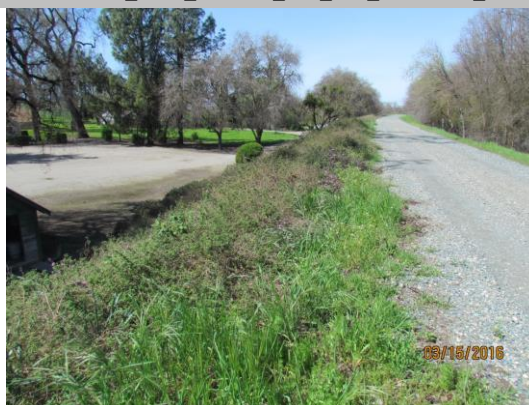
Photo 1 of 2 : SP_2018_NA0016_435_173_20180306_00074.jpg

LM Start	18.66	Rating **	M	Issue No.	173
LM End	18.70	Issue Type +	En	Location *	LS
Category	Earthen Levee			GPS Latitude/Longitude	
				Start	End
Item	Vegetation			38.952765 °	38.953219 °
				-121.839661 °	-121.840199 °
DWR ID	DWR_NA0016_01_s_2016_173				
Comment Code					
V6 : Landscaping					
Inspector Comment					
Permit number 16487. Owner needs to maintain/trim vegetation.

View of the landscaping on the landward side of the levee looking upstream. Spring 2016.

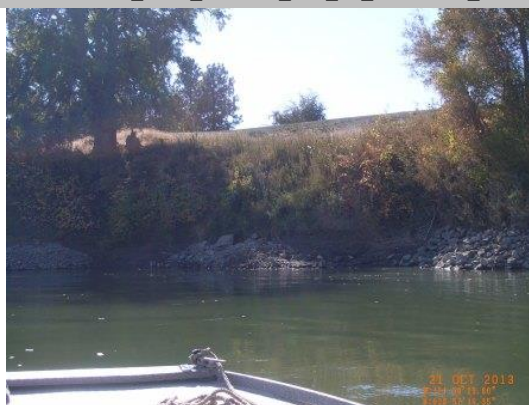
Photo 1 of 1 : SP_2018_NA0016_435_10_20180306_00009.jpg

USACE 2013 Photo #1

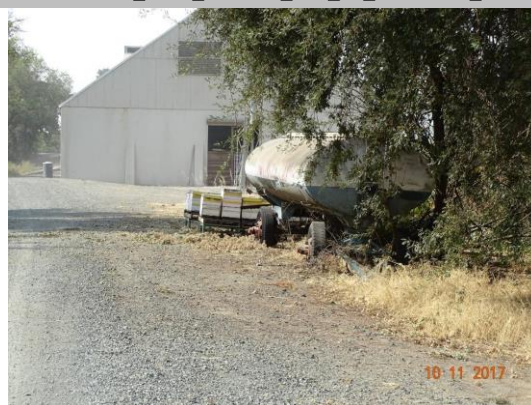
Photo 1 of 2 : SP_2018_NA0016_435_26_20180306_00017.jpg

LM Start	19.12	Rating **	M	Issue No.	26
LM End	19.12	Issue Type +	En	Location *	LS
Category	Earthen Levee			GPS Latitude/Longitude	
				Start	End
Item	Encroachments			38.957180 °	38.957180 °
				-121.837442 °	-121.837442 °
DWR ID	DWR_NA0016_01_s _ 2012_26				
Comment Code					
EQ : Equipment					
Inspector Comment					
Beehives and tank on landside slope.

Updated view of equipment and beehives. Fall 2017.

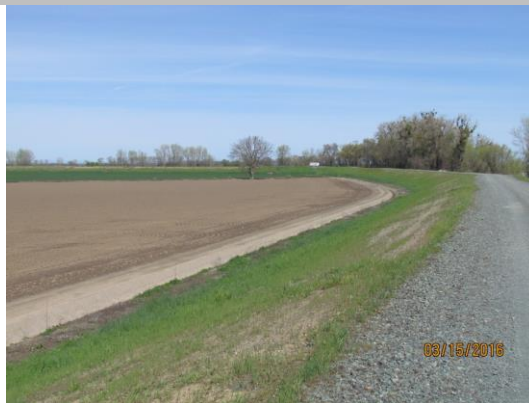
Photo 1 of 2 : SP_2018_NA0016_435_31_20180306_00023.jpg

LM Start	19.15	Rating **	M	Issue No.	31
LM End	19.61	Issue Type +	En	Location *	LS
Category	Earthen Levee			GPS Latitude/Longitude	
				Start	End
Item	Encroachments			38.957405 °	38.962648 °
				-121.836965 °	-121.834368 °
DWR ID	DWR_NA0016_01_s_2012_31				
Comment Code					
DT : Ditch					
Inspector Comment					
Concrete lined ditch up to LM 19.40. Soil ditch continues on until LM 19.61.

View of the ditch on the landward side of the levee looking upstream. Spring 2016.

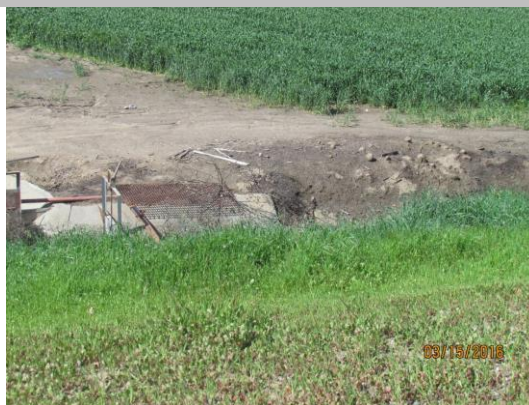
Photo 2 of 2 : SP_2018_NA0016_435_31_20180306_00024.jpg

Concrete lined ditch stops at levee mile 19.40.

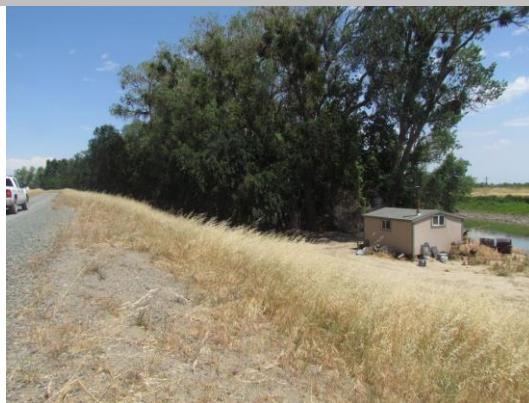
Photo 1 of 1 : SP_2018_NA0016_435_96_20180306_00038.jpg

LM Start	19.37	Rating **	M	Issue No.	96
LM End	19.37	Issue Type +	En	Location *	WS
Category	Earthen Levee			GPS Latitude/Longitude	
				Start	End
Item	Encroachments			38.959642 °	38.959642 °
				-121.834004 °	-121.834004 °
DWR ID	DWR_NA0016_01_s_2015_96				
Comment Code					
BU : Building					
Inspector Comment

View of the building on the waterward side of the levee looking upstream. Spring 2015.

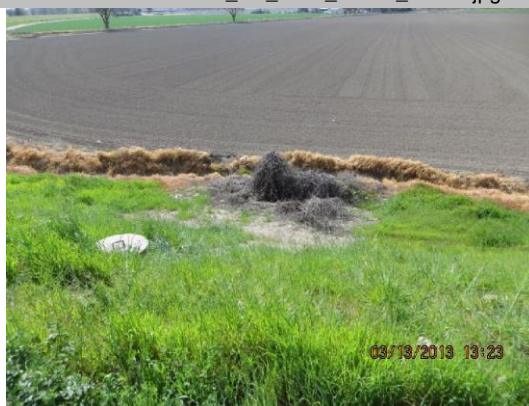
Photo 1 of 2 : UCIP_SP_2018_10253_17449.jpg

Comment Code					
Inspector Comment					
FS_ID:10253					
DS_ID:20246					
EP_NO: 1507					
Repair Type: Non-Urgent					
Crossing Status: Found					
UCIP Comments: Pipe appears abandoned. Needs to be abandoned properly.					
FIELD_STRUCT_DESC: 14-inch steel irrigation pipe through the levee, 8.4 feet below the crown. Gate valve on the waterside (WS). Siphon breaker inside a 24-inch corrugated metal riser unit on the landside (LS) slope. Concrete distribution box inside an irrigation ditch on the LS toe. (Permit No. 1507, 1950 - Morgan Miller Jr.). [Additional Reference(s): DWR Levee Log, 2006. USACE Sacramento O&M Manual 130, May 1960 (HLM 19.74)].					
FS Date: 3/13/2013

CMP Riser on shoulder and concrete distribution box under heavy blackberry cover at LS toe.

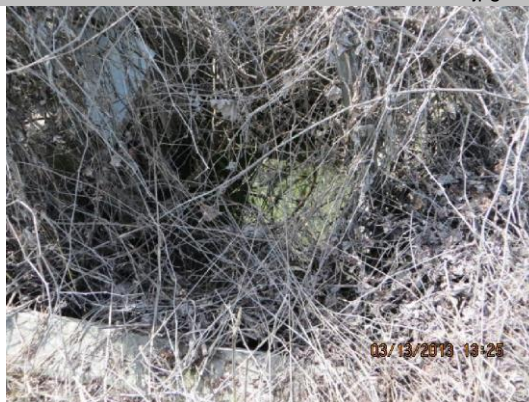
Photo 2 of 2 : UCIP_SP_2018_10253_17448.jpg

Concrete distribution box under heavy blackberry cover at LS toe.

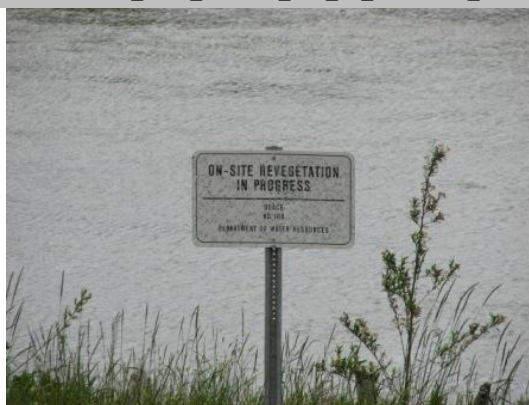
Photo 1 of 2 : SP_2018_NA0016_435_30_20180306_00021.jpg

LM Start	22.12	Rating **	A/W	Issue No.	30
LM End	22.42	Issue Type +	Ob	Location *	WS
Category	Earthen Levee			GPS Latitude/Longitude	
				Start	End
Item	Vegetation			38.989528 °	38.989722 °
				-121.816020 °	-121.810488 °
DWR ID	DWR_NA0016_01_s_2012_30				
Comment Code					
V8 : Environmental Requirements.					
Inspector Comment

Revegetation site. Photo taken spring 2012.

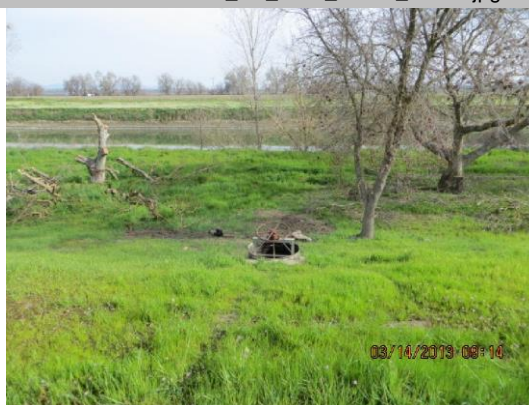
Photo 1 of 3 : UCIP_SP_2018_10261_17466.jpg

Comment Code					
Inspector Comment					
FS_ID:10261 DS_ID:20249 EP_NO: 9374 Repair Type: Non-Urgent Crossing Status: Found UCIP Comments: Appears abandoned. Pipe should be properly abandoned. FIELD_STRUCT_DESC: 1 of 4: 36-inch corrugated metal irrigation pipe through the levee, 20 feet below the crown. One corrugated metal cutoff wall installed by the United States Army Corp of Engineers, 1955. Slide gate inside a 36-inch corrugated metal riser unit on the waterside (WS) slope. Pump on the WS bank. Concrete standpipe on the landside (LS) toe. (Automatic Board Order (ABO) issued as Permit No. 9374, 1974 - Richard H. Moore). [Additional Reference(s): USACE Sacramento O&M Manual 130, May 1960 (HLM 24.03)]. FS Date: 3/14/2013

36-inch cmp riser on WS slope with slide gate.

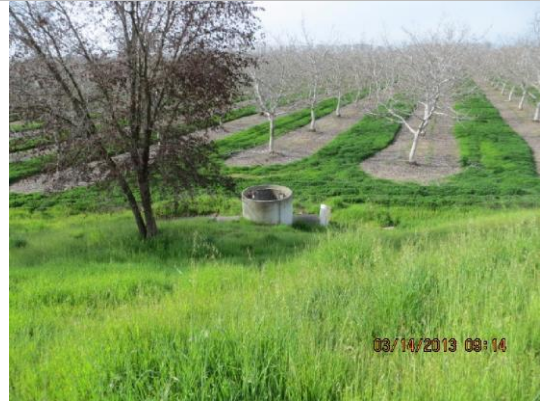
Photo 2 of 3 : UCIP_SP_2018_10261_17465.jpg

Item	DWR UCIP Field Study			38.998247 °	38.998247 °	
				-121.800236 °	-121.800236 °	
DWR ID						
Comment Code						
Inspector Comment						
FS_ID:10261						
DS_ID:20249						
EP_NO: 9374						
Repair Type: Non-Urgent						
Crossing Status: Found						
UCIP Comments: Appears abandoned. Pipe should be properly abandoned.						
FIELD_STRUCT_DESC: 1 of 4: 36-inch corrugated metal irrigation pipe through the levee, 20 feet below the crown. One corrugated metal cutoff wall installed by the United States Army Corp of Engineers, 1955. Slide gate inside a 36-inch corrugated metal riser unit on the waterside (WS) slope. Pump on the WS bank. Concrete standpipe on the landside (LS) toe. (Automatic Board Order (ABO) issued as Permit No. 9374, 1974 - Richard H. Moore). [Additional Reference(s): USACE Sacramento O&M Manual 130, May 1960 (HLM 24.03)].						
FS Date: 3/14/2013

Concrete distribution riser on LS toe.

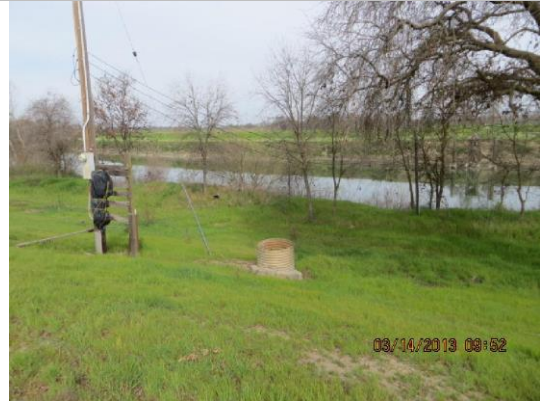
Photo 1 of 2 : UCIP_SP_2018_10265_17486.jpg

Comment Code						
Inspector Comment						
FS_ID:10265 DS_ID:20251 EP_NO: 9328 Repair Type: Non-Urgent Crossing Status: Found UCIP Comments: Appears abandoned. Needs to be abandoned properly. FIELD_STRUCT_DESC: 24-inch corrugated metal irrigation pipe through the levee, 20 feet below the crown. Slide gate inside a 36-inch corrugated metal riser unit on the waterside (WS) slope. 7-foot by 9-foot distribution box at the toe of the landside (LS) slope. (Automatic Board Order (ABO) issued as Permit No. 9328, 1974 - Wayne A. Hine). [Additional Reference(s): DWR Levee Log, 2006. USACE Sacramento O&M Manual 130, May 1960 (HLM 25.02)]. FS Date: 3/14/2013

Slide gate in 36-inch CMP riser on WS slope.

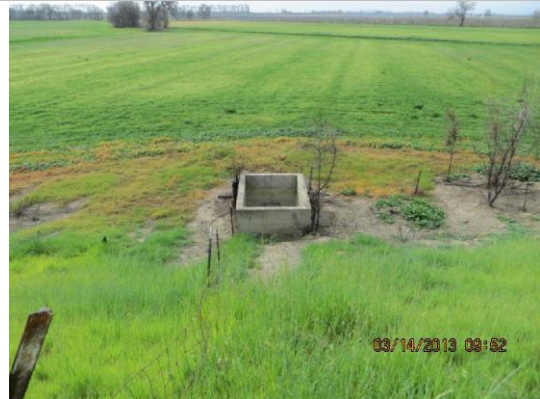
Photo 2 of 2 : UCIP_SP_2018_10265_17485.jpg

7-foot by 9-foot distribution box at LS toe.

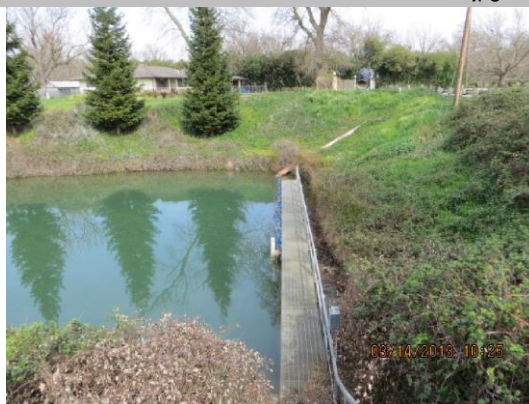
Photo 3 of 3 : UCIP_SP_2018_10271_17499.jpg

Walkway and gates at LS toe.

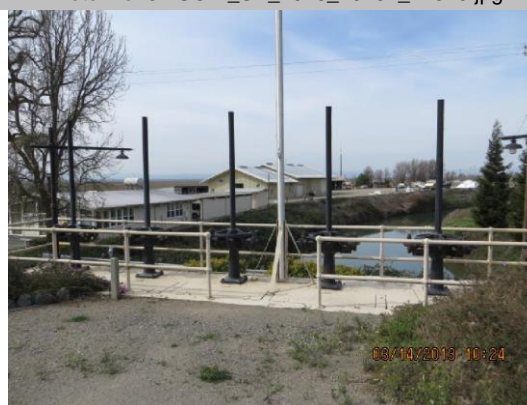
Photo 2 of 3 : UCIP_SP_2018_10284_17529.jpg

Slide gates on LS shoulder.

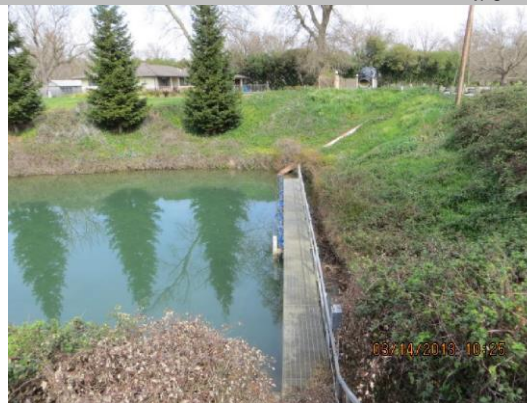
Photo 3 of 3 : UCIP_SP_2018_10284_17528.jpg

Walkway and gates in canal at LS toe.

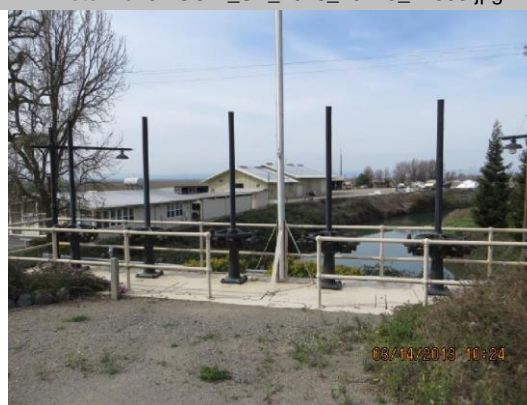
Photo 2 of 3 : UCIP_SP_2018_10273_17503.jpg

Slide gates on LS shoulder

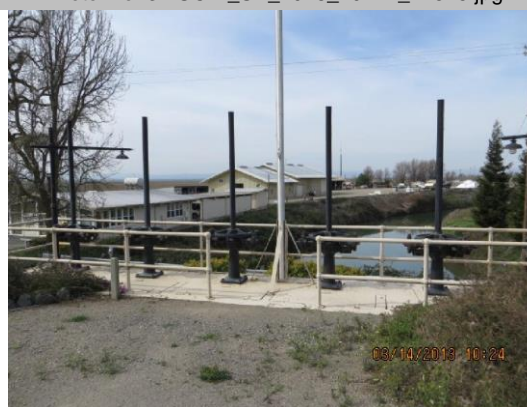
Photo 2 of 3 : UCIP_SP_2018_10277_17515.jpg

Slide gates on LS shoulder.

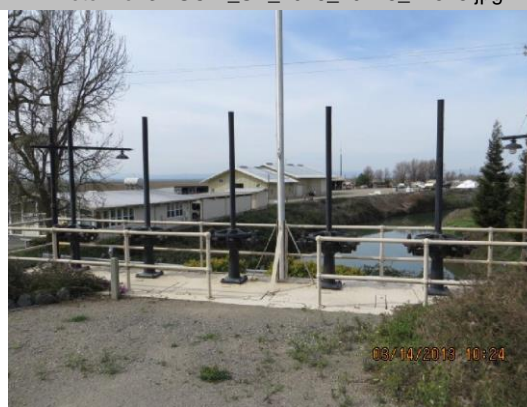
Photo 2 of 3 : UCIP_SP_2018_10278_17518.jpg

Slide gates on LS shoulder.

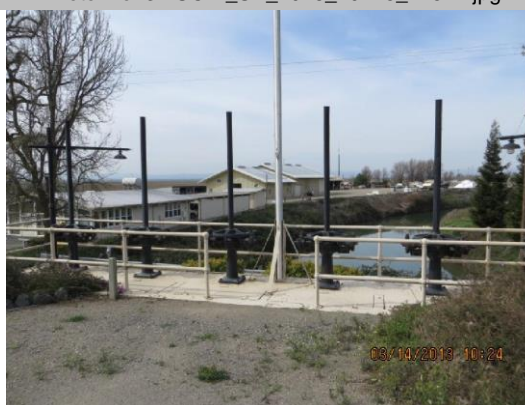
Photo 2 of 3 : UCIP_SP_2018_10276_17512.jpg

Slide gates on LS shoulder.

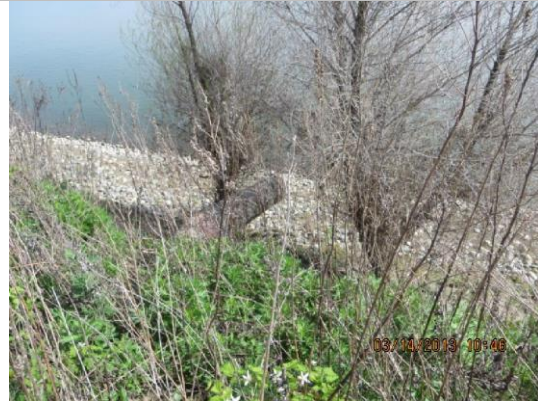
Photo 3 of 3 : UCIP_SP_2018_10285_17534.jpg

LM Start	26.46	Rating **	M	Issue No.	1585 (cont)
LM End	26.46	Issue Type +	En	Location *	
Category	Supplemental			GPS Latitude/Longitude	
				Start	End
Item	DWR UCIP Field Study			39.023842 °	39.023842 °
				-121.823077 °	-121.823077 °
DWR ID					
Comment Code					
Inspector Comment					
FS_ID:10285 DS_ID:20253 EP_NO: 9136 Repair Type: Non-Urgent Crossing Status: Found UCIP Comments: Pipe appears to be abandoned. Pipe needs to be abandoned properly. FIELD_STRUCT_DESC: *ABANDONED* 18-inch coated steel drainage pipe through the levee, 3 feet below the crown. Steel cutoff wall at the centerline. Air release valve on the waterside (WS) shoulder. Slide gate inside a 72-inch diameter corrugated metal riser unit on the landside (LS) toe. (Permit No. 9136, 1973 - Durst Brothers). [Additional Reference(s): DWR Levee Log, 2006]. FS Date: 3/14/2013

Pipe at Rivers edge.

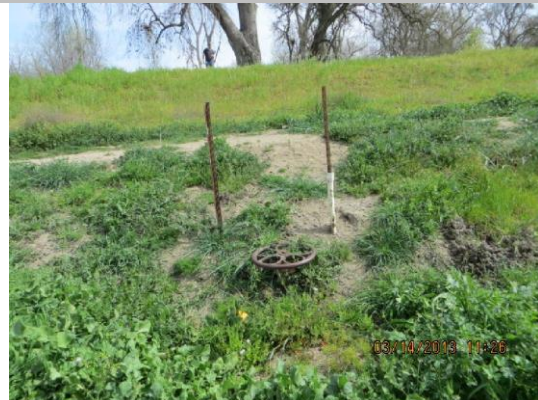
Photo 1 of 2 : UCIP_SP_2018_10289_17543.jpg

Comment Code					
Inspector Comment					
FS_ID:10289 DS_ID:20256 EP_NO: 9368 Repair Type: Non-Urgent Crossing Status: Found UCIP Comments: Need to abandon pipe properly. FIELD_STRUCT_DESC: 24-inch steel irrigation pipe through the levee, 16.2 feet below the crown. Pump on the waterside (WS) bank. Gate valve on the landside (LS) end. Concrete box at the LS toe of the slope. Irrigation well 6 feet from the toe of the landward slope. (Automatic Board Order (ABO) issued as Permit No. 9368, 1974 - Fredinand Erdman). [Additional Reference(s): DWR Levee Log, 2006. USACE Sacramento O&M Manual 131, May 1960 (HLM 27.79) (standpipe on the WS)]. FS Date: 3/14/2013

gate valve off landside toe.

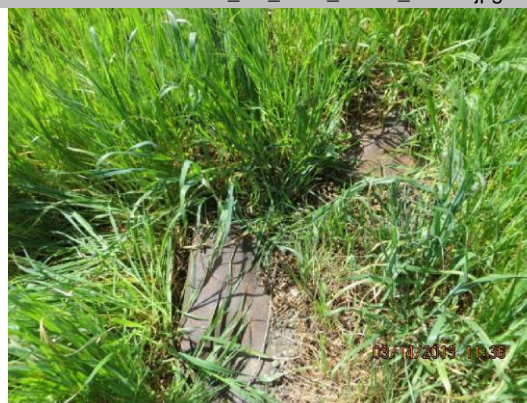
Photo 2 of 2 : UCIP_SP_2018_10290_17544.jpg

LM Start	27.46	Rating **	M	Issue No.	1587 (cont)	
LM End	27.46	Issue Type +	En	Location *		
Category	Supplemental			GPS Latitude/Longitude		
				Start	End	
Item	DWR UCIP Field Study			39.033814 °	39.033814 °	
				-121.833158 °	-121.833158 °	
DWR ID						
Comment Code						
Inspector Comment						
FS_ID:10290 DS_ID:20416 EP_NO: N/A Repair Type: Non-Urgent Crossing Status: Indicator Found UCIP Comments: Appears this pipe is abandoned and visible on WS slope in pieces. Need to verify proper abandonment. FIELD_STRUCT_DESC: *ABANDONED* 24-inch pipe of an unknown type and material through the levee, 6.2 feet below the crown. Pipe debris on the waterside (WS) slope. [Additional Reference(s): USACE Sacramento O&M Manual 131, May 1960 (HLM 27.79)]. FS Date: 3/14/2013

Pipe debris on WS slope.

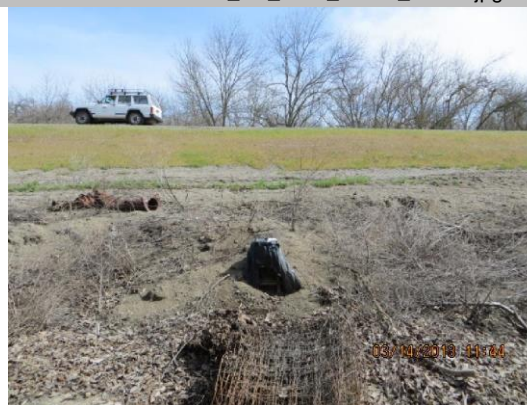
Photo 1 of 3 : UCIP_SP_2018_10291_17548.jpg

LM Start	27.54	Rating **	M	Issue No.	1588
LM End	27.54	Issue Type +	Ma	Location *	
Category	Supplemental			GPS Latitude/Longitude	
				Start	End
Item	DWR UCIP LMA Responsibility			39.034870 °	39.034870 °
				-121.833501 °	-121.833501 °
DWR ID					
Comment Code					
Inspector Comment					
FS_ID:10291 DS_ID:20257 EP_NO: 9355 Repair Type: Non-Urgent Crossing Status: Found UCIP Comments: Pipe needs to be properly abandoned. FIELD_STRUCT_DESC: *ABANDONED* 24-inch steel drainage pipe through the levee, 14 feet below the crown. Slide gate on the waterside (WS) end. Gate valve on the landside (LS) end. (24-inch pipe [HLM 27.89] authorized under Automatic Board Order (ABO) issued as Permit No. 9355, 1974 - Alvin Gustafson). [Additional Reference(s): DWR Levee Log, 2006. USACE Sacramento O&M Manual 131, May 1960 (HLM 27.89)]. FS Date: 3/14/2013

Gate valve buried on LS toe.

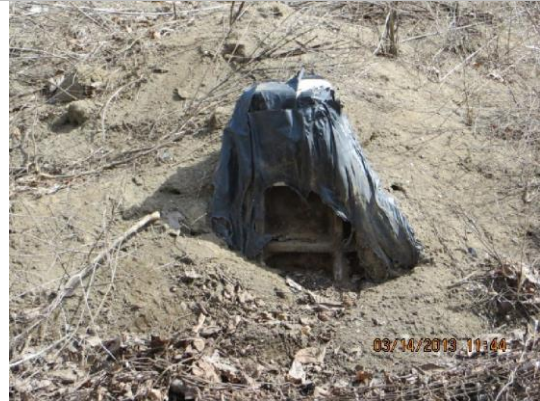
Photo 2 of 3 : UCIP_SP_2018_10291_17547.jpg

Gate valve buried on LS toe.

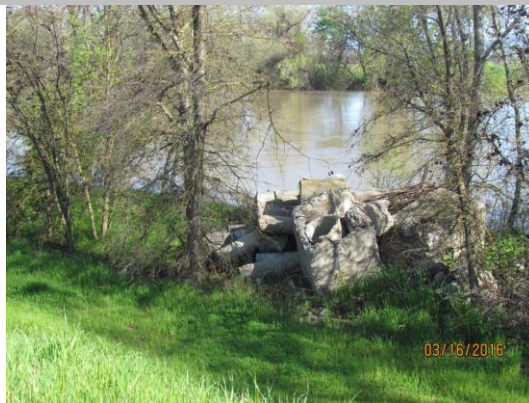
Photo 1 of 1 : SP_2018_NA0016_435_59_20180306_00030.jpg

LM Start	28.02	Rating **	M	Issue No.	59
LM End	28.02	Issue Type +	En	Location *	WS
Category	Earthen Levee			GPS Latitude/Longitude	
				Start	End
Item	Encroachments			39.040750 °	39.040750 °
				-121.835299 °	-121.835299 °
DWR ID	DWR_NA0016_01_s_2012_59				
Comment Code					
DE : Debris					
Inspector Comment					
piles of concrete

View of the pile of concrete on the waterward berm of the levee. Spring 2016.
